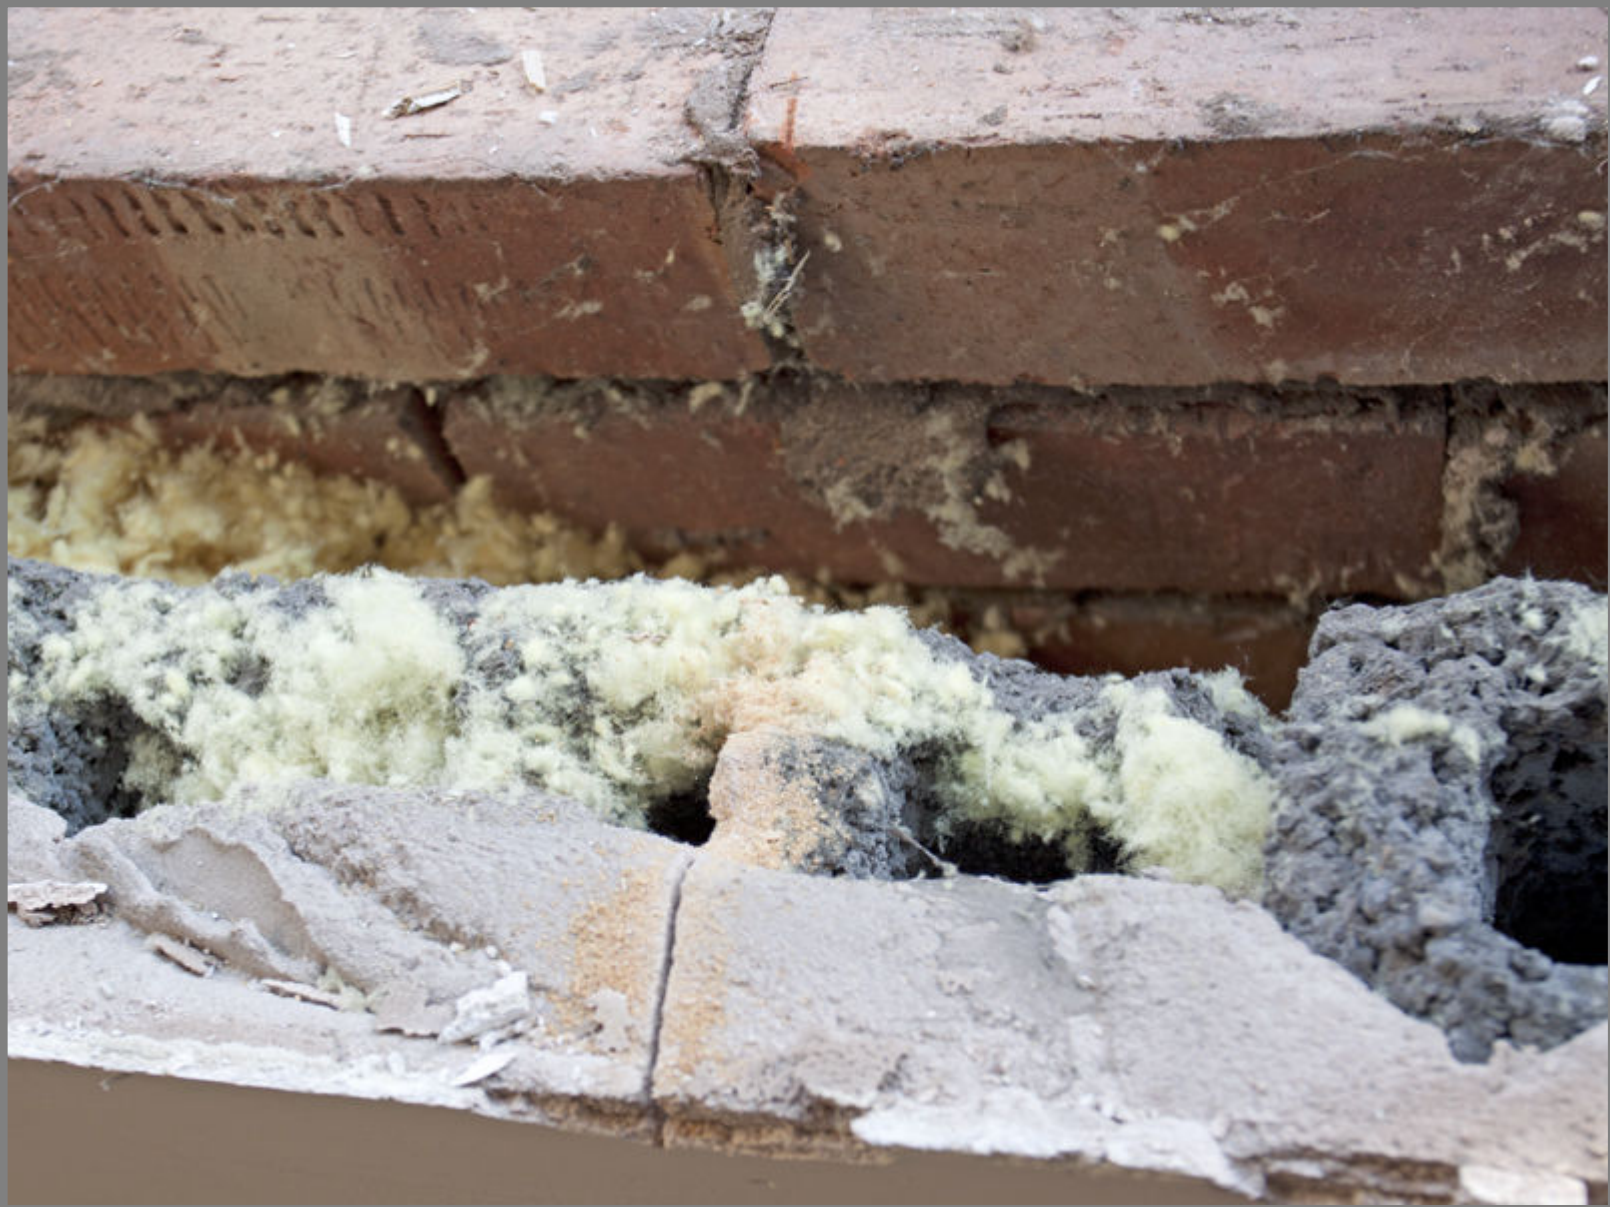
This first image is of the void viewed from inside the house and is therefore on the left of the window. The line of insulation slopes then rapidly falls away at a steep angle. The void painfully obvious and that image taken immediately the void was discovered.

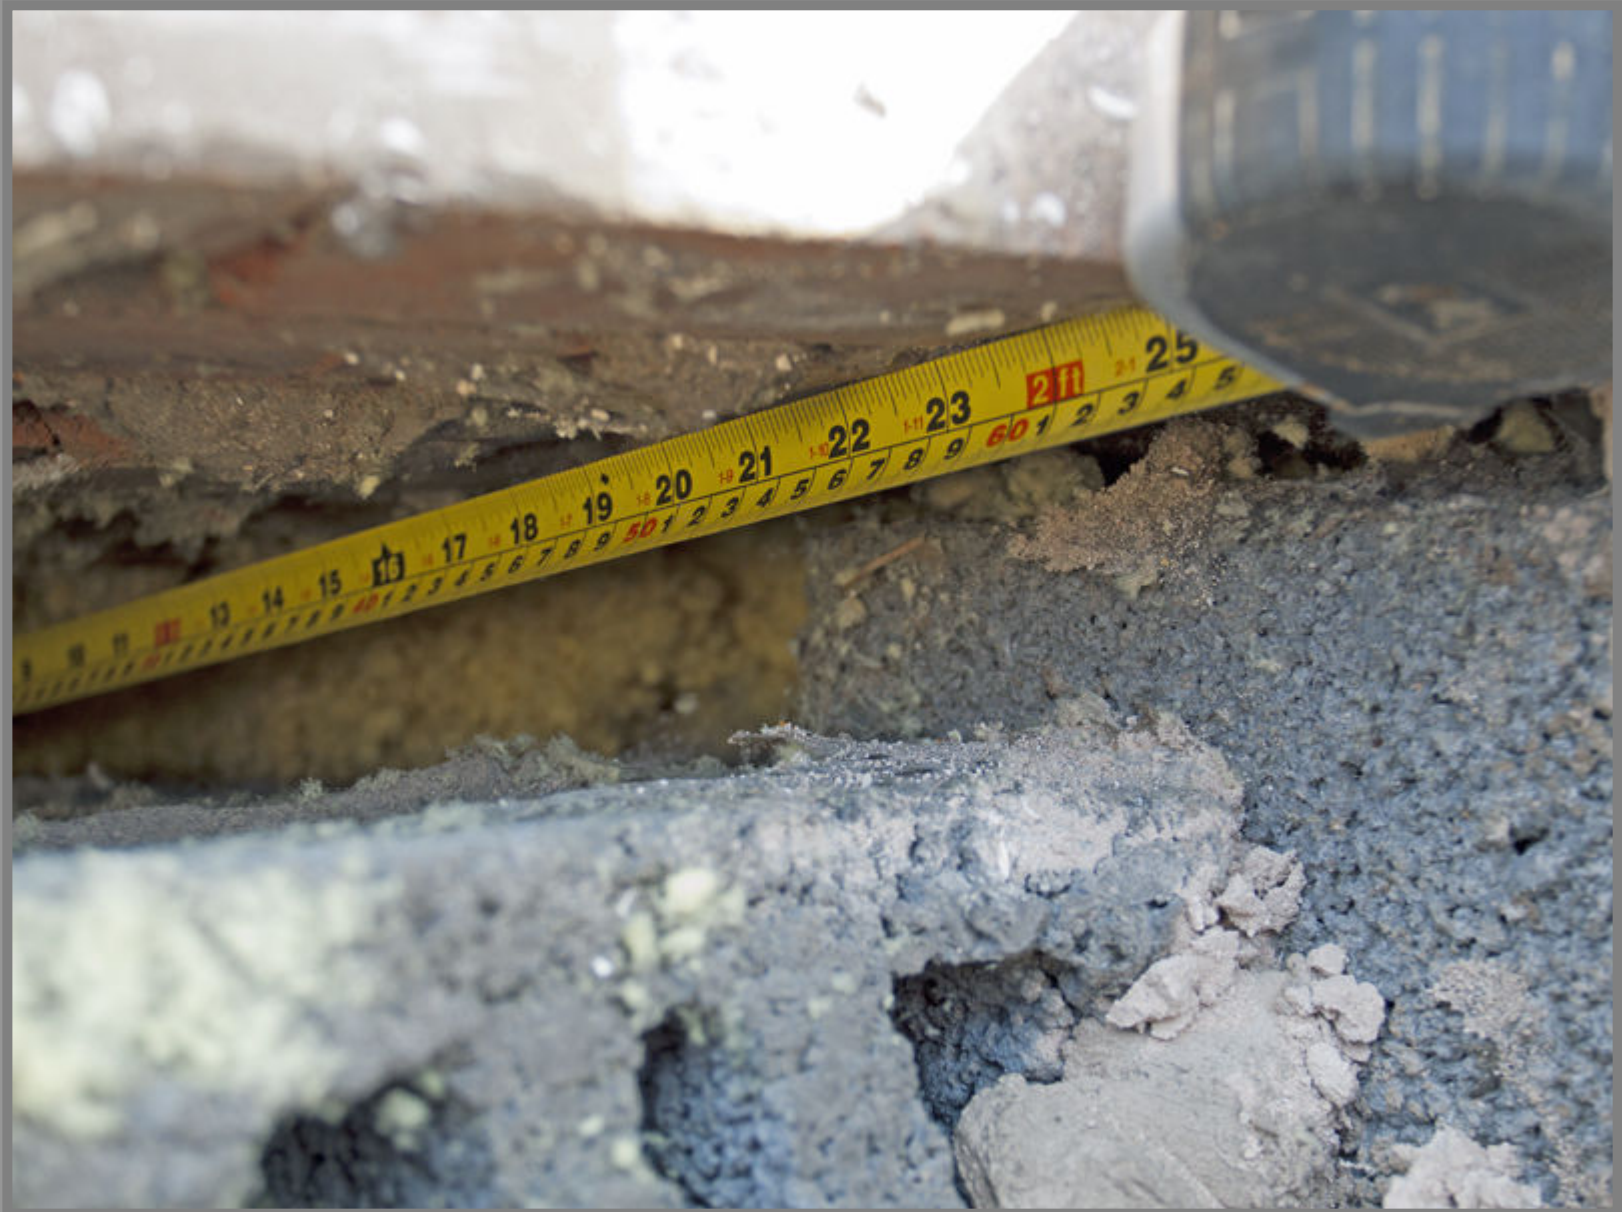
This second image is of the void viewed from inside the house and is therefore on the right of the window. The line of insulation falls away at a steep angle about 200mm from the end. The void is variable obviously but at the deepest point 640mm from the top edge of the brick. Image taken immediately the void was discovered. Not acceptable especially as I was at the time carefully fitting a new uPVC window with B rated frames and K glass (fully compliant).
